# Ningbo Sanyou Environmental Protecting Technology Co., Ltd

#### **Technical Report:**

Sample Description:	Two Drum Spill Pallet(See below)			
Manufacturer:	/	Sample Quantity:	/	
Buyer:	/	Product Type	/	
Country of Origin:	China	Country of Destination:	/	
Color:	/	SKU No.:	/	
Protocol No.:	/	Previous Report No.:	/

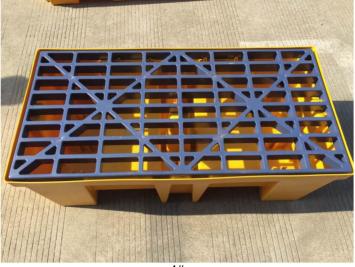
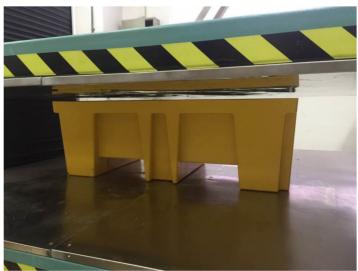
1#

No.	Name	Model	Weight(g)	Size(mm)	Category
1	Two Drum Spill Pallet	UP-1202/1204	21520	1330X660X430	One metal grid add one yellow plastic pallet

No.	Test Result	
1	1 No damage was observed on the sample after test

Take the sample into the equipment, Opening the testing machine, pressure on the sample for 220N to make the sampe with the pressure plate normal contact, pressure speed is 3mm/min, when the pressure reached 5000kgf to stop the test.
