## Ningbo Sanyou Enivironmental Protecting Technology Co.,Ltd

### **Technical Report:**

Sample Description:	Two Drum Spill Pallet (See belo	w )	
Manufacturer:	/	Sample Quantity:	1
Buyer:	/	Product Type	1
Country of Origin:	China	Country of Destination:	/
Color:	/	SKU No.:	1
Protocol No.:	/	Previous Report No.:	1

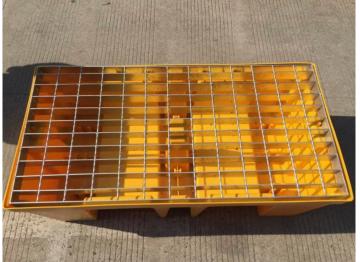
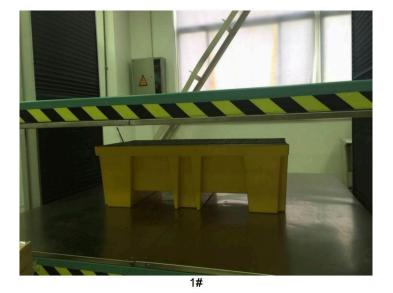
1#

No.	Name	Model	Weight(g)	Size(mm)	Category
1	Two Drum Spill Pallet	UP-1206	1	1330X660X430	One metal grid add one yellow plastic pallet

Take the sample into the equipment, Opening the testing machine, pressure on the sample for 220N to make the sampe with the pressure plate normal contact, pressure speed is 3mm/min, when the pressure reached 5000kgf to stop the test.

No.	Test Result	
1	No damage was observed on the sample after test
